Lessons from Madrid

Dr Roger Pope, BCSA Technical Consultant

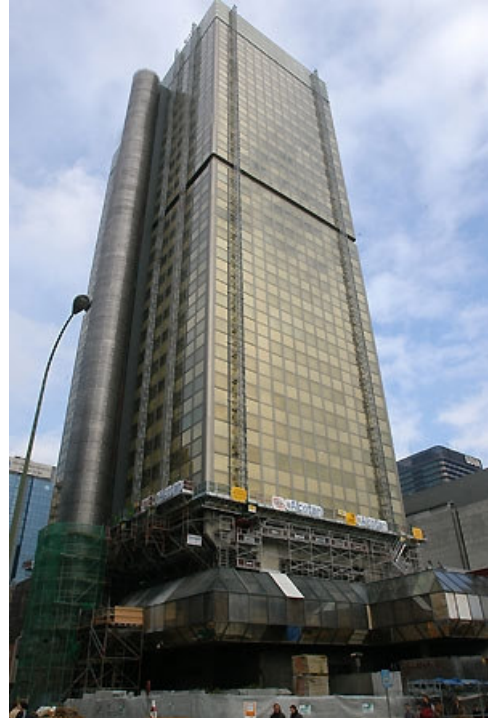
Windsor Building being refurbished

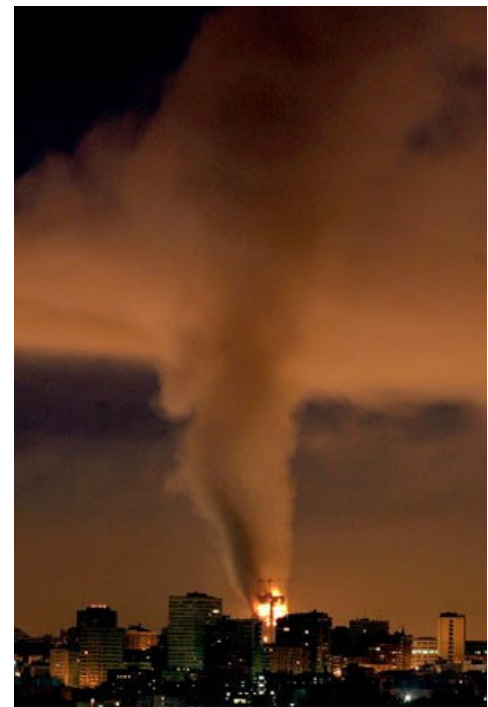
Windsor Building engulfed by fire

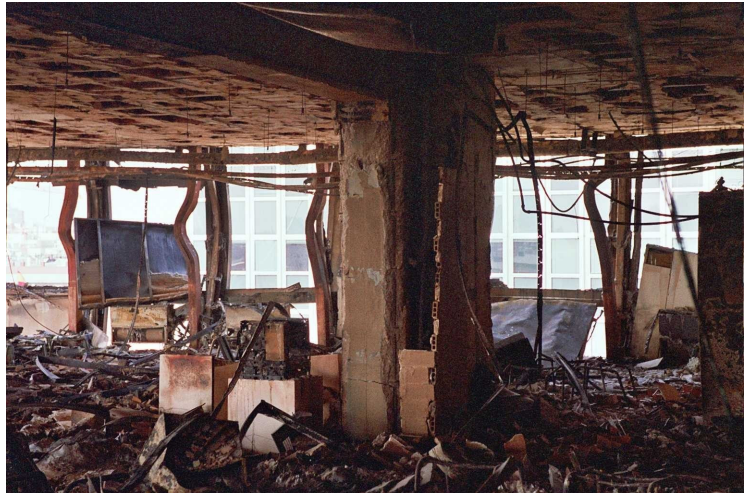
However, it is interesting to see what happened on the 9th level. The picture shows that the unprotected steel mullions buckled as they were restrained against thermal expansion. But collapse did not ensue. Why?

Buckling of 9th level mullions

The answer is that the loads were taken by multiple alternative load paths – a classic robustness provision. Mullions above from level 10 to 17 and below from level 8 down were able to distribute and share the loads as the 9th level mullions failed. The fact that there were 60 mullions per floor level added to the number of alternative load paths available.

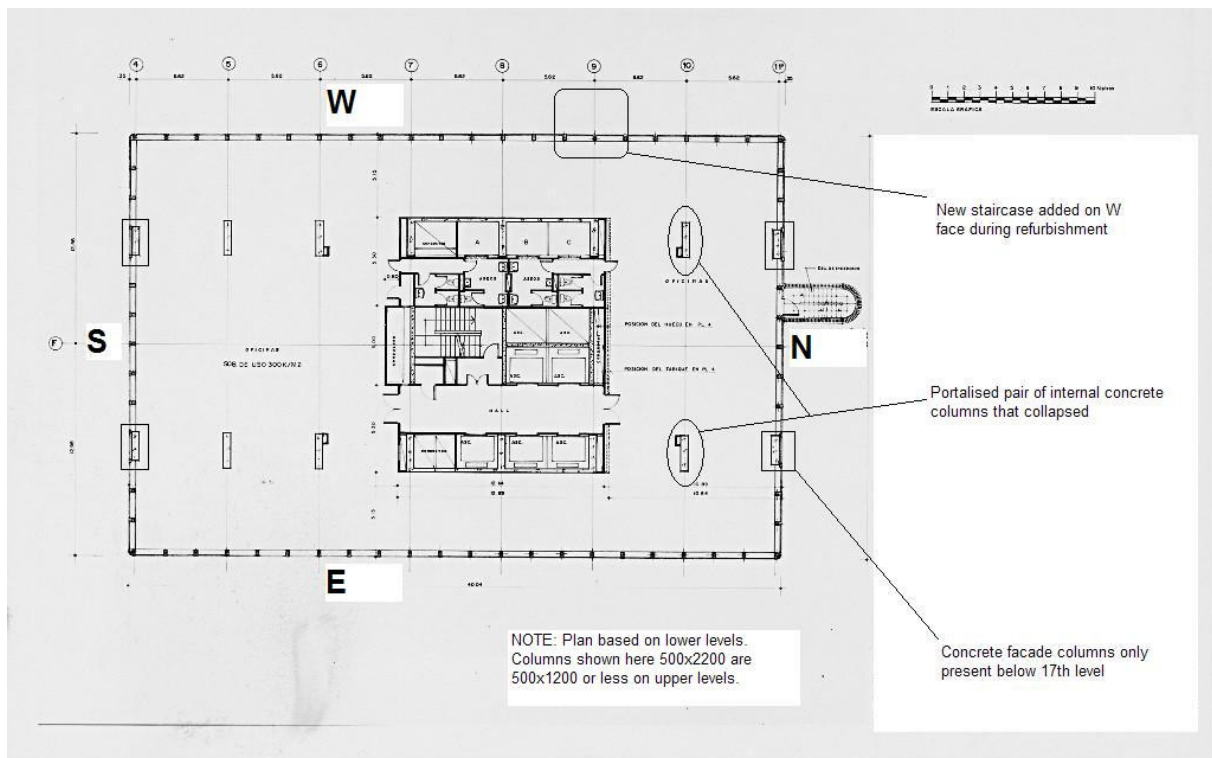
Floor plan

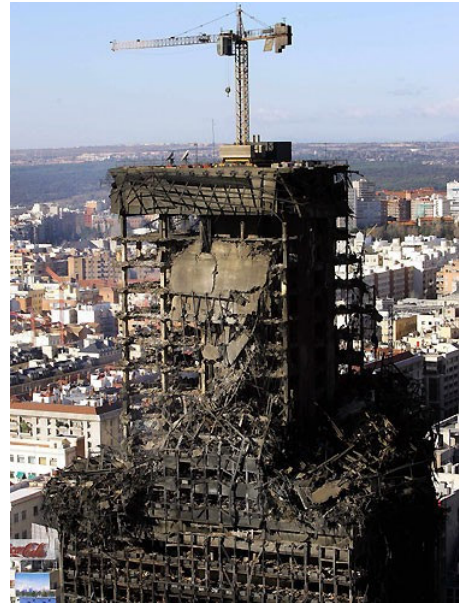
The fire started on the 21st floor level. As shown in the picture taken from the east after the fire, the serviced storey between 16th and 17th levels arrested all the progressive collapse that occurred to the upper superstructure. Such “strong floors” in multi-storey buildings are another classic robustness provision.

Collapse arrested by strong floor

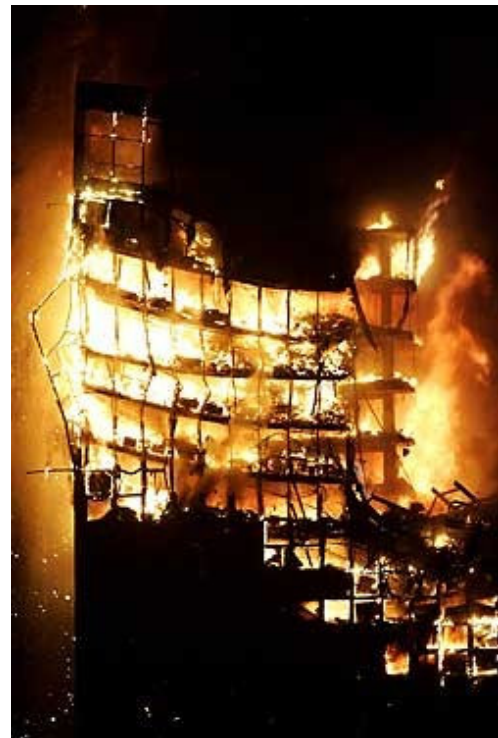
About 4 hours after ignition

However, the lack of compartmentation meant that the fire raged over several floors at once. Below the 17th level the fire protected mullions could still provide alternative load paths. Above that level, weakening of the unprotected mullions over more than one adjacent level simultaneously meant that the alternative load paths were far more widely distributed and placed much more demand on the concrete floor slabs to redistribute the loads. Once a slab failed on one level in one area, the added tensions above and collapsing debris loads below led to progressive failure of several storeys until arrested by the strong floor. This is what happened at the southern end of the building.

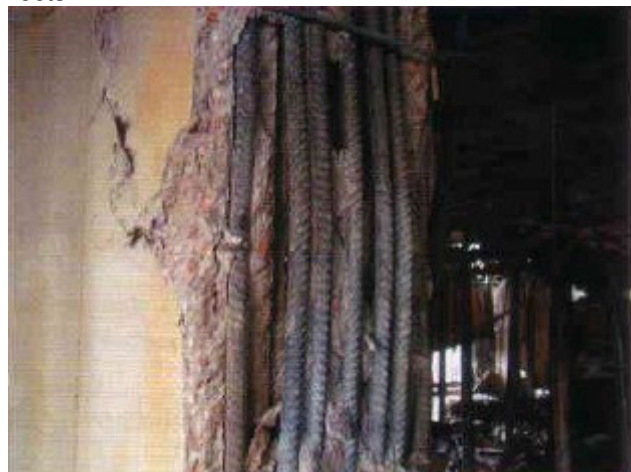
Effect of heat on 8th level columns

The difference may be due to the fact that the fire started at the northern end and had been raging seriously for about 1³/₄ hours when the collapse occurred. The next clue is what happened at level 8. The picture shows a column with extensive spalling, buckling of the exposed reinforcement and fracture of the containment stirrups. Restrained thermal

expansion can explain these observed effects from heating of the column. This column was 2200 x 500 with 52 no 32 dia rebars and loss of the capacity of the end seven bars would not be critical.

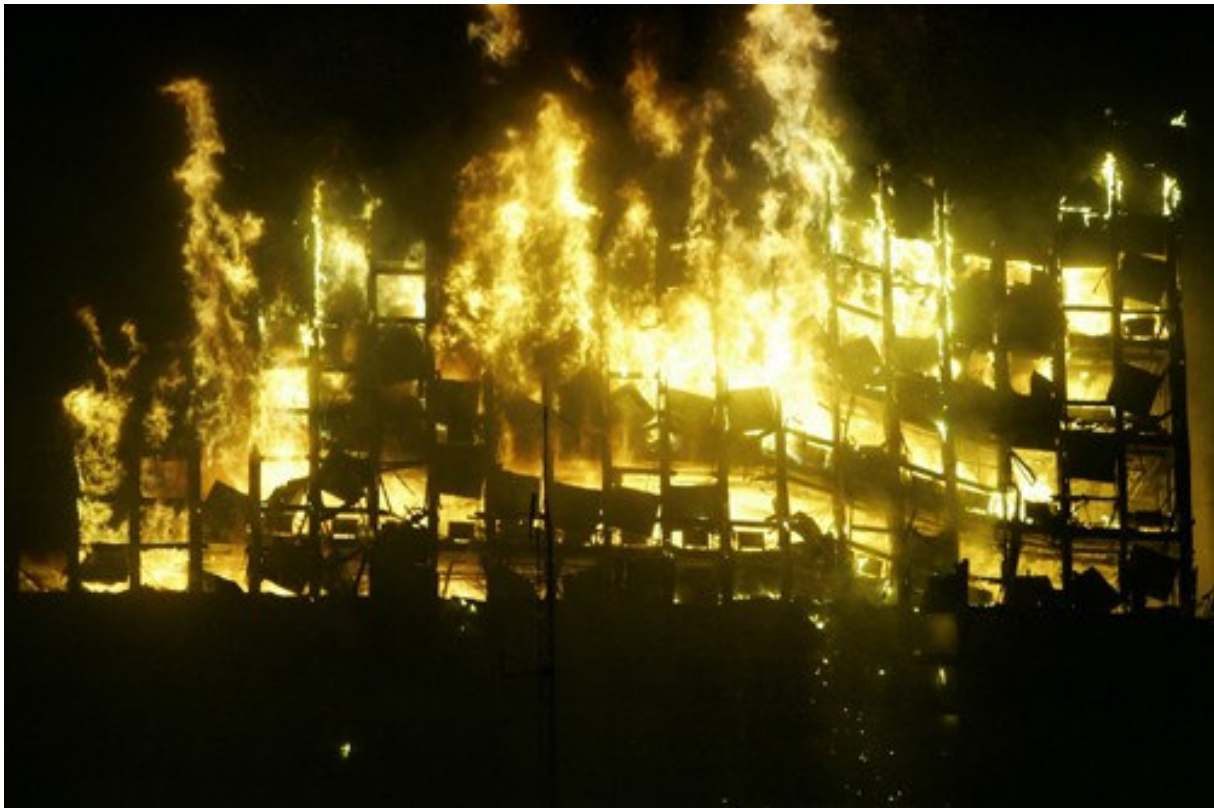
East façade as northern end collapses

The final clue supporting this conclusion is in this picture of the east façade as the northern end collapses. Whilst much of the façade glazing has gone, the steel mullion columns are intact. It seems that a “soft storey” is the reason why collapse is taking place at the right hand (northern) end, with intact floors above dropping as an integral assembly. If so, it was only load shedding at the floor where the concrete columns failed that mattered together with loss of column capacity from prolonged exposure to the fire at that level. Had the steel mullions been properly fire protected, the multiple load paths they provided would almost certainly have helped redistribute the loads shed by internal concrete columns weakened by the fire.
